## Service Bulletin SB-0005

RE: Mechanical Seal Sand Cannon - For serial #'s 4130-4213

Date: 08/08/24

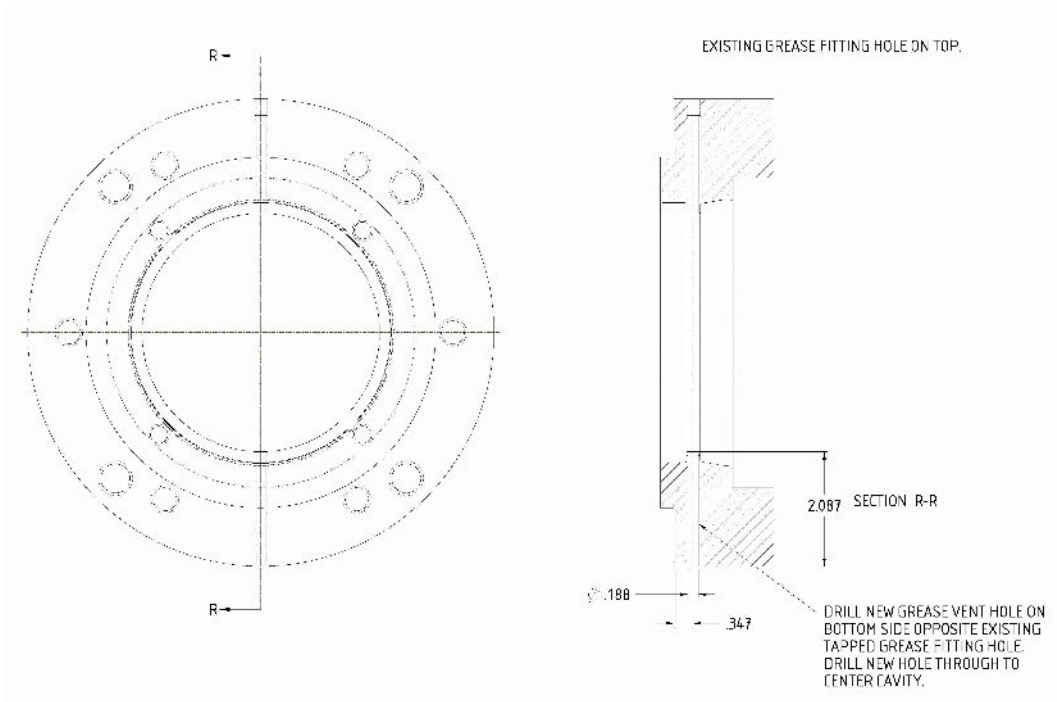
This Service Bulletin is to announce the addition of grease vent hole to the Trelleborg outer housing. This Vent will eliminate the build up of pressure inside the seal cavity.

Drill new grease vent hole on the bottom side opposite existing tapped grease fitting hole. Drill hole through to center cavity.
